APPENDIX A
CENTER STREET BRIDGE PHOTO LOG

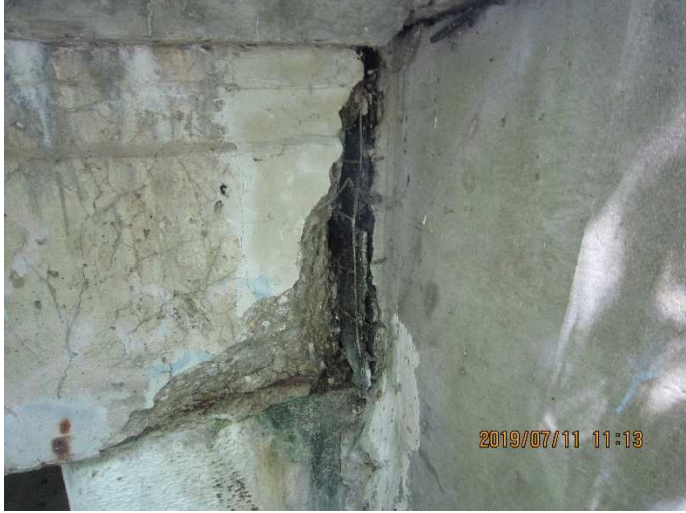
| | <p>Photo 1: 19" x 22" Corner spall with strands exposed with section loss on beam 1 of span 1 at west abutment. Wire mesh reinforcement exposed. Beam 1 at west abutment.</p> |

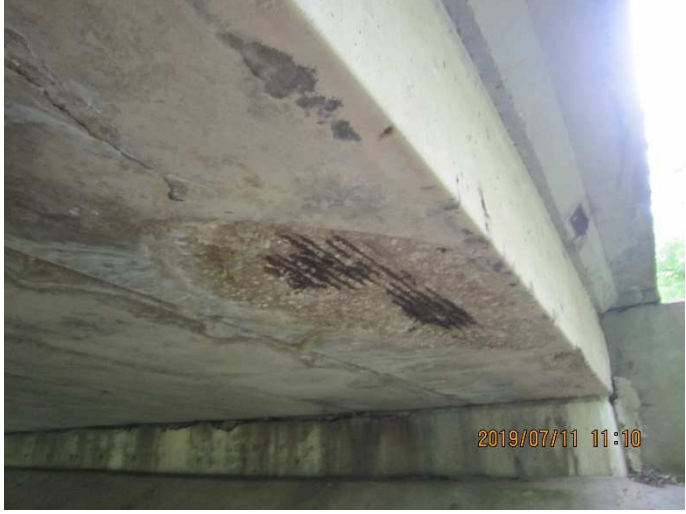
| | <p>Photo 2: 60"x30" spall with 9 exposed strands and 4 of those are severed. 30"x12" delaminated area next to it with no spall. Beam 1 of West Span.</p> |

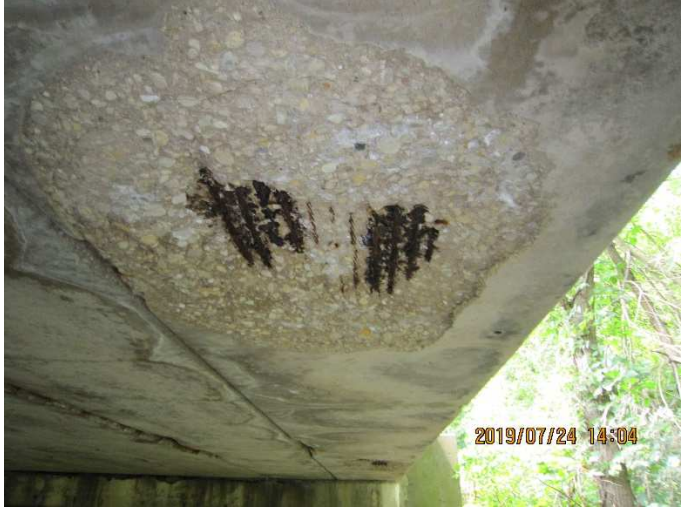
| | <p>Photo 3: 40"x30" spall with 8 exposed strands near midspan of West Span in Beam 1. Located 15 feet from the west pier. No strands appear to be broken. Strands are exposed in less than 50% of the bottom of Beam 1. 26"x24" delaminated area, with no spall, located directly to the west of this spall.</p> |

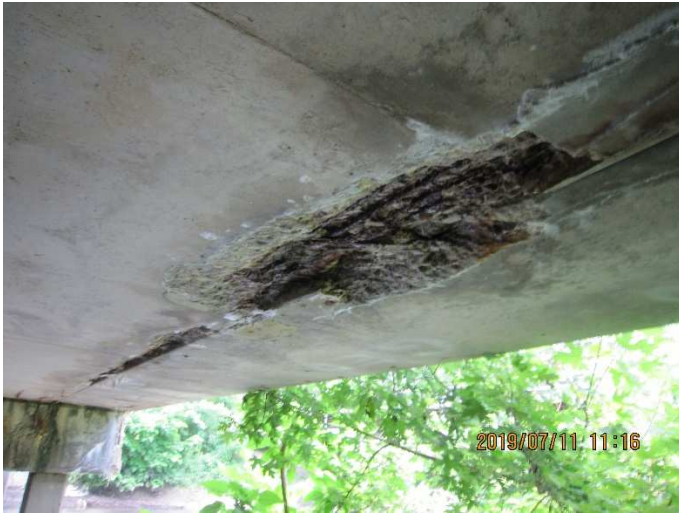
Photo 4: Corners of beams 10 and 11 near midspan of West Span, spalled with 5 exposed strands. 3 of them broken.

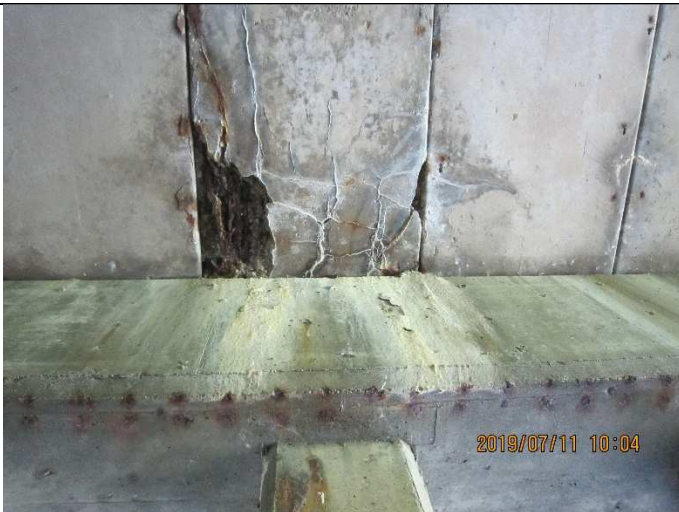
Photo 5: Map cracking at the east end of Beam 6 in the West Span has developed into a spall, exposing 3 strands with one of them severed.

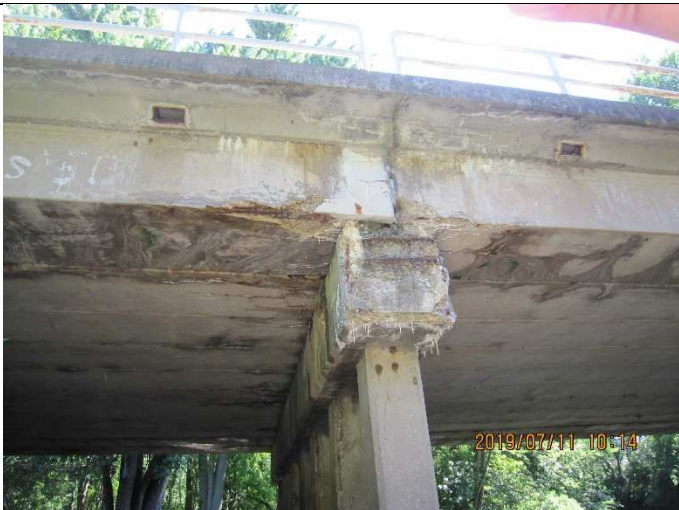
Photo 6: Spalling with exposed reinforcement at the south end of the West Pier cap.

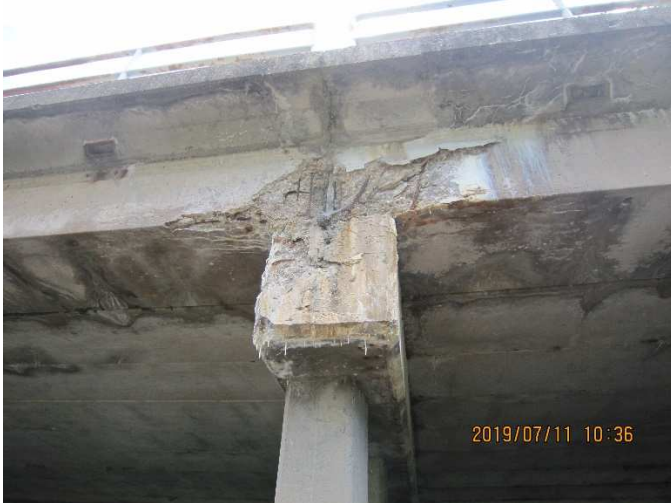
Photo 7: South end of the East Pier cap is spalling. Beams above the cap have spalled and exposed the reinforcement.

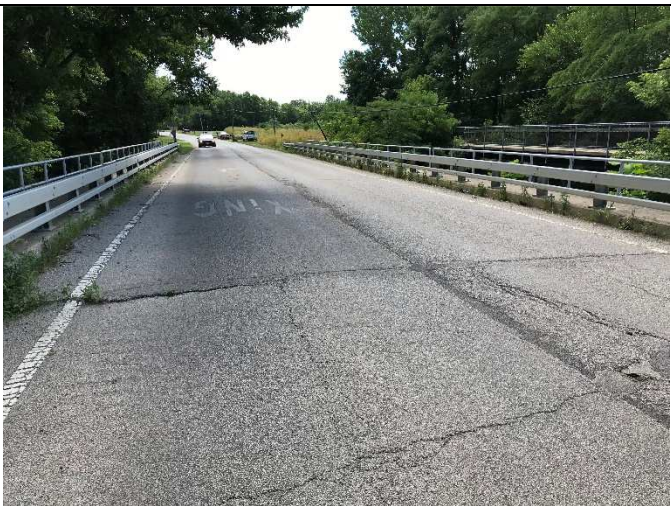
Photo 9: Pavement condition at the west end of the bridge. Centerline is raveling. Some settling past the bridge end.
